# Manhole Inspection Summary

Manhole # S33QQ\_101MH

Insp Date: **10/28/08 3:32 PM**

**Location** Address: **2515 HOWARD ST**

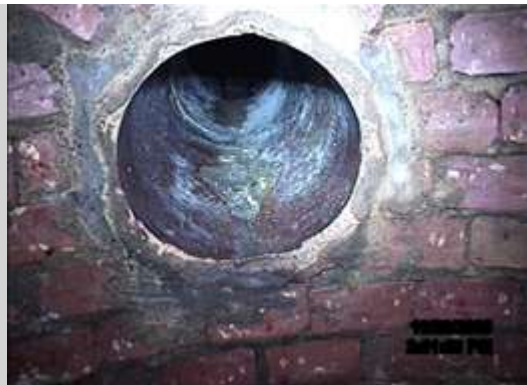
### 8 in. Circular Gravity Sewer Pipe In @ 3 O'Clock

Invert Depth: **6.72** (ft.) Flow Characteristics: **Slow**

Infiltration: **None** Pipe Seal Cond: **Unknown**

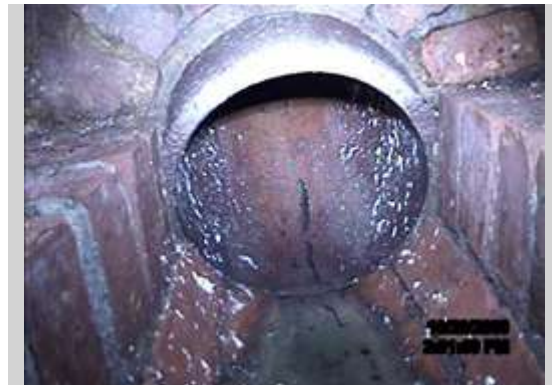
### Drop In @ 3 O'Clock

Drop: **Inside** Rod and Bar  
Angled: **Yes** Reading: **8.62** (ft.)  
Inv Depth: **9.62** (ft.)

Drop Condition: **Open**

Connects To: **Dead End**

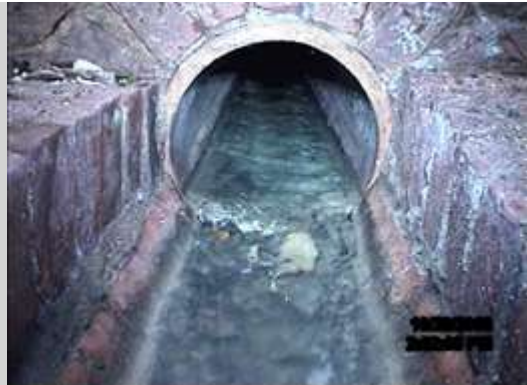
Pipe In @ 6 O'Clock

Infiltration: **None** Pipe Seal Cond: **Unknown**
